**ROV INVESTIGATIONS OF THE DKM *U-166* SHIPWRECK SITE TO
DOCUMENT THE ARCHAEOLOGICAL AND BIOLOGICAL ASPECTS OF THE
WRECK SITE**

FINAL PERFORMANCE REPORT

NOAA AWARD NO. NA03OAR4600103

October 2004

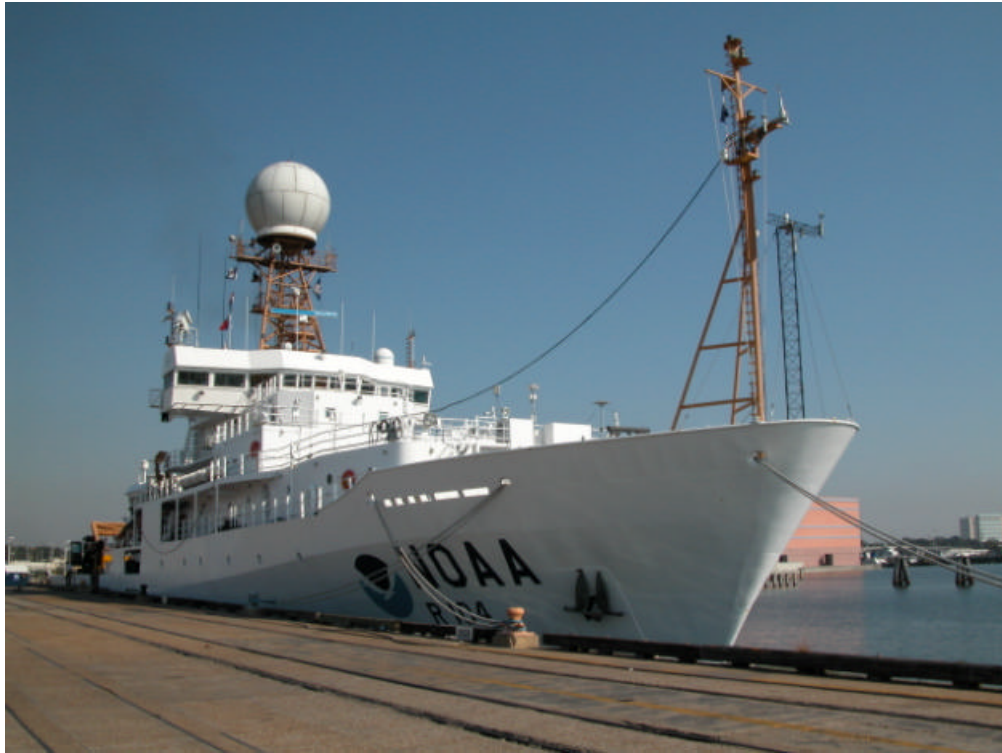
Figure 3. The NOAA Research Vessel *Ronald H. Brown*.

The DKM *U-166*'s location nearly 50 miles off the southeastern Louisiana coast and over eight hours away from the nearest port required that the support vessel remain on station for the entire project. The vessel used for this project would have to be capable of extended self-sustaining operations away from port facilities. The NOAA Office of Ocean Exploration provided such a vessel, the Research Vessel *Ronald H. Brown*. The *Ronald H. Brown* is a 274-foot NOAA research ship capable of working independently offshore for long periods of time. It has extensive laboratory facilities, a heavy-duty crane system, and ample deck space for the ROV. Additionally, the vessel is equipped with a dynamic positioning system that allows the ship to remain on station without the use of an anchor spread (Figure 3).

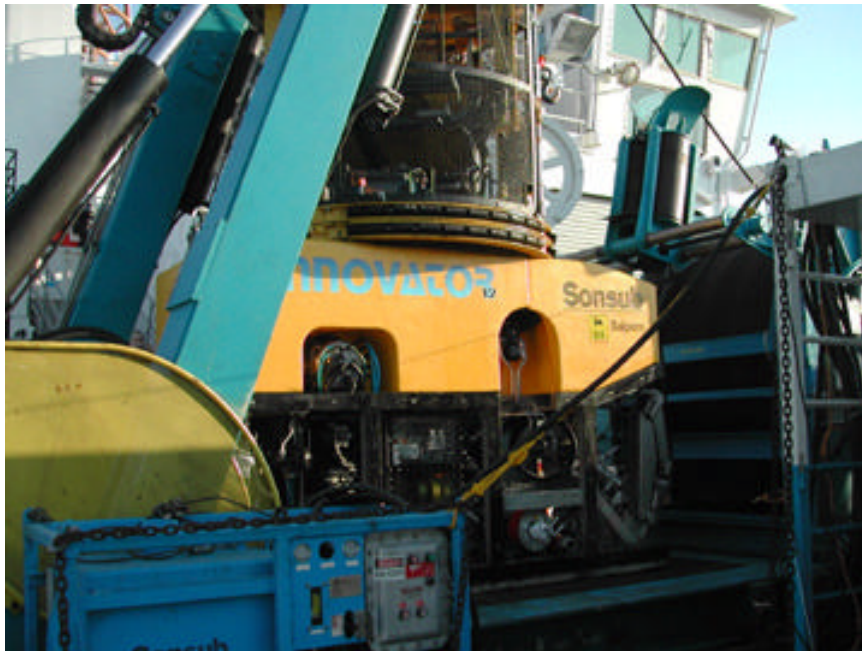
Sonsub's Innovator Class ROV (Figure 4) is rated at 200 horsepower and is capable of operating at depths up to 3,000 meters. It is equipped with 5 and 7-function manipulator arms, scanning sonar, high intensity lighting, and a fiber-optic uplink. It uses a top hat Tether Management System (TMS) with a positively buoyant tether. The use of a TMS with a positive tether is essential to prevent the possibility of the wreck being damaged by the tether dragging on the seafloor. Additionally, for the DKM *U-166* investigations, the Innovator ROV was outfitted with a 3-chip digital video camera, digital still camera, and an acoustic positioning beacon both on the ROV and the TMS.

Figure 4. The SONSUB Innovator ROV used for the DKM *U-166* project.

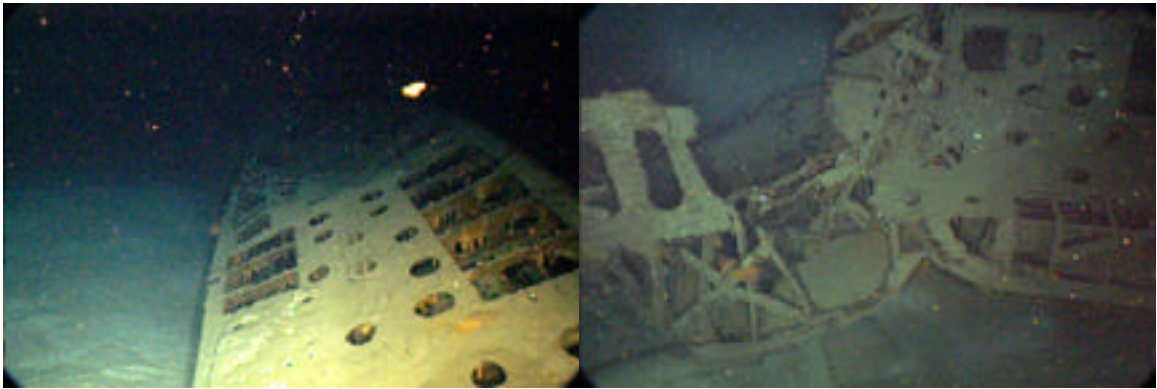
The bow section of the DKM *U-166* lies near the western extent of the site. It is an approximately 50-foot long section of the forward hull that is partially imbedded in the seafloor and resting on its starboard side at a relatively acute angle. It is uncertain how much of the forward hull is buried, although there appears to have been a substantial amount of sediment displacement from the impact into the seafloor. This portion of the U-boat appears to have been torn away from the stern section near the forward torpedo loading hatch area. The prow of the vessel is facing south with the damaged area to the north. The bow remains appear to be covered with a thin layer of corrosion product and silt. A substantial growth of rusticles was noted near the damaged portions of the bow.

Still visible in the wreckage are the remains of the forward torpedo winch that would have been used to load torpedoes through the forward torpedo hatch.

Figure 9. Images of the DKM *U-166* showing possible depth charge indentation (l) and damaged area near what would have been the forward torpedo loading hatch (r).

- The bow section exhibits significant structural damage where it separated from the stern section, including a large indentation in the deck that is interpreted as the result of a depth charge explosion.

The investigation of the bow section provided a revealing look at a possible cause of the U-boat's destruction. A large indentation was visible in the top of the deck, which appears to be the result of a depth charge explosion. Just aft of this damaged area the bow had torn away from the rest of the vessel and the serrated metal flares outward as if caused by an internal explosion. Possibly a depth charge exploded very near the deck, rupturing the pressure hull, which then caused an internal explosion. It was speculated that salt water rushing into the battery room or a torpedo in that location of the U-boat could have caused such an explosion.

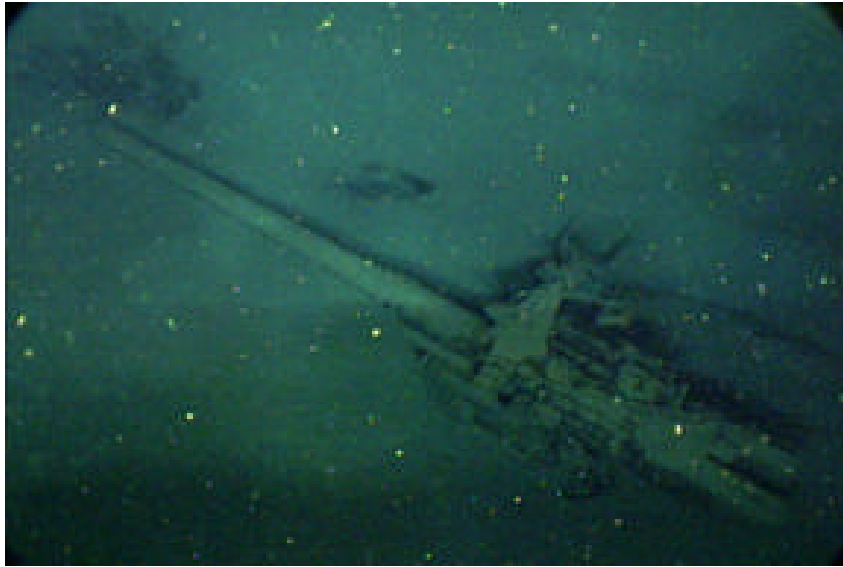
Moving down the stern wreckage from forward to aft, most of the remaining forward deck is buried under sediment, the 105-mm deck gun is the first visible deck feature (Figure 10). It is intact and setting upright on the deck. The gun muzzle is facing forward and the bore plug is still in place.

Figure 10. Overhead view of the 105-mm forward deck gun.

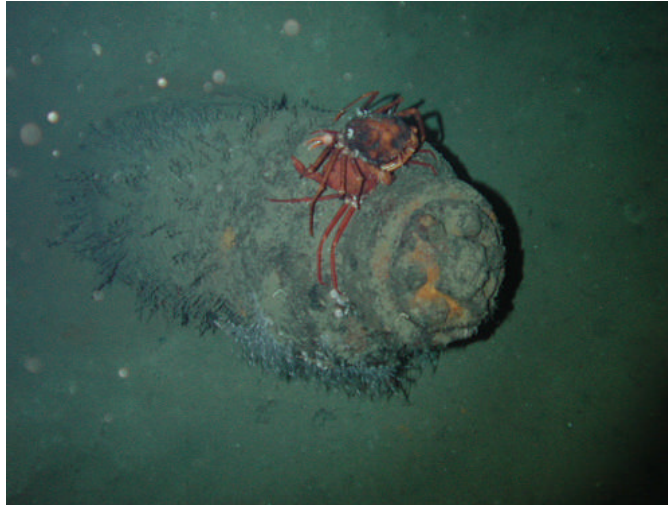
pressurized cylinders were not within the debris field (Figure 16). The use of these cylinders is uncertain, but they were all deeply imbedded in the seafloor, one up to the valve neck.

Figure 16. Pressurized cylinder from DKM *U-166* debris field (Artifact No. 47).

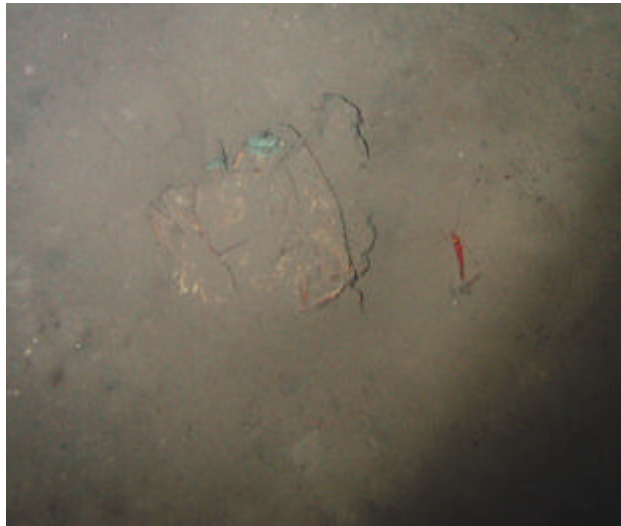
Personal equipment or personal items of the DKM *U-166*'s crew were also observed scattered within the debris field. These materials are probably from the forward portion of the pressure hull where the crew was quartered and where the hull was most likely breached. Among the items observed were shoes, leather heavy weather gear, a dinner tray, and several Dräger Lung rescue devices (Figure 17). The Dräger Lungs were intended for shallower water escapes from the U-boat, but the crew of the DKM *U-166* never had that chance.

Figure 17. A Dräger Lung from the DKM *U-166* debris field (Artifact No. 127).

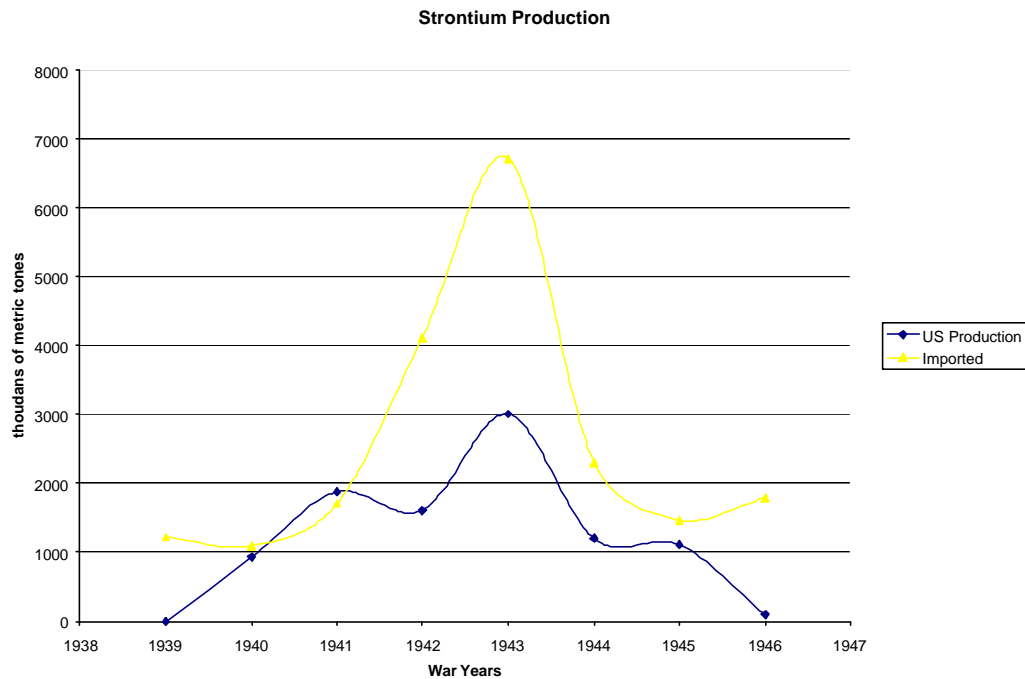
The order of magnitude difference in the concentration of strontium between the rusticle analyses from S.S. *Robert E. Lee* (0.11%), and DKM *U-166* (0.21%) with HMHS *Britannic* (0.012%) is of concern. Given that both S.S. *Robert E. Lee* and DKM *U-166* were both sunk within a militarily very active zone in the Gulf of Mexico at the height of World War II it could be surmised that these higher concentration could be related to this. The United States of America imported significant quantities of strontium during the war but not prior to the build up for that war (Figure 18).

Figure 18. Strontium Use in USA during World War II period

Figure 18 gives the US production and importation of strontium during the War years. Note that virtually no strontium was imported for two decades prior to 1939 and it

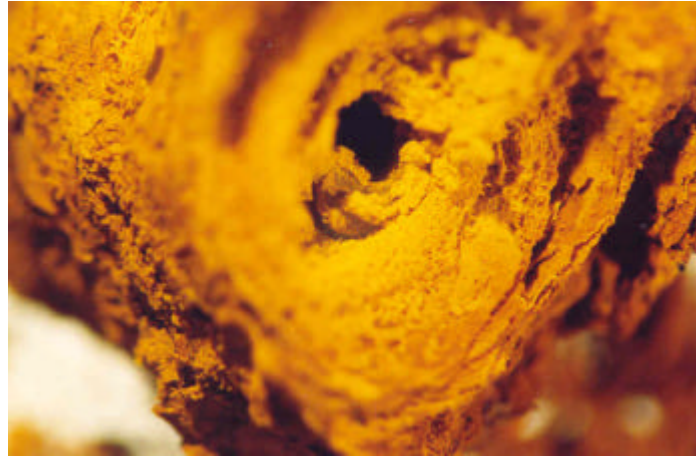
the form of crystalline structures within the rusticles. In other rusticles studied from other sites, the general observation had been that these structures are whorled to some extent, generally showed a lack of repeatable structures and did not appear to follow a geometric pattern. Frequently, however, the specimens from both ships under study did follow a geometric pattern (Figures 20 and 21) that was also frequently set up in a planar manner.

Figure 19. Central Water Conduit in Rusticle from the S.S. *Robert E. Lee*

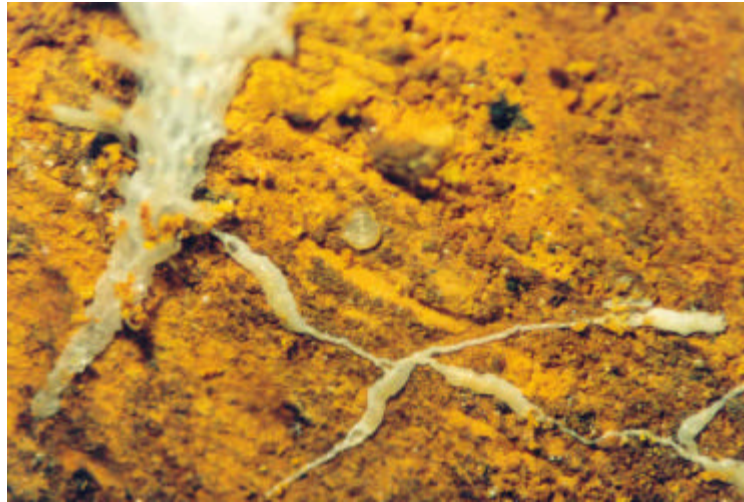
Figure 22. Resin-Like Columns on fractured Rusticle Surfaces, HMHS *Britannic* (No magnification, width of image is approximately 5 mm)

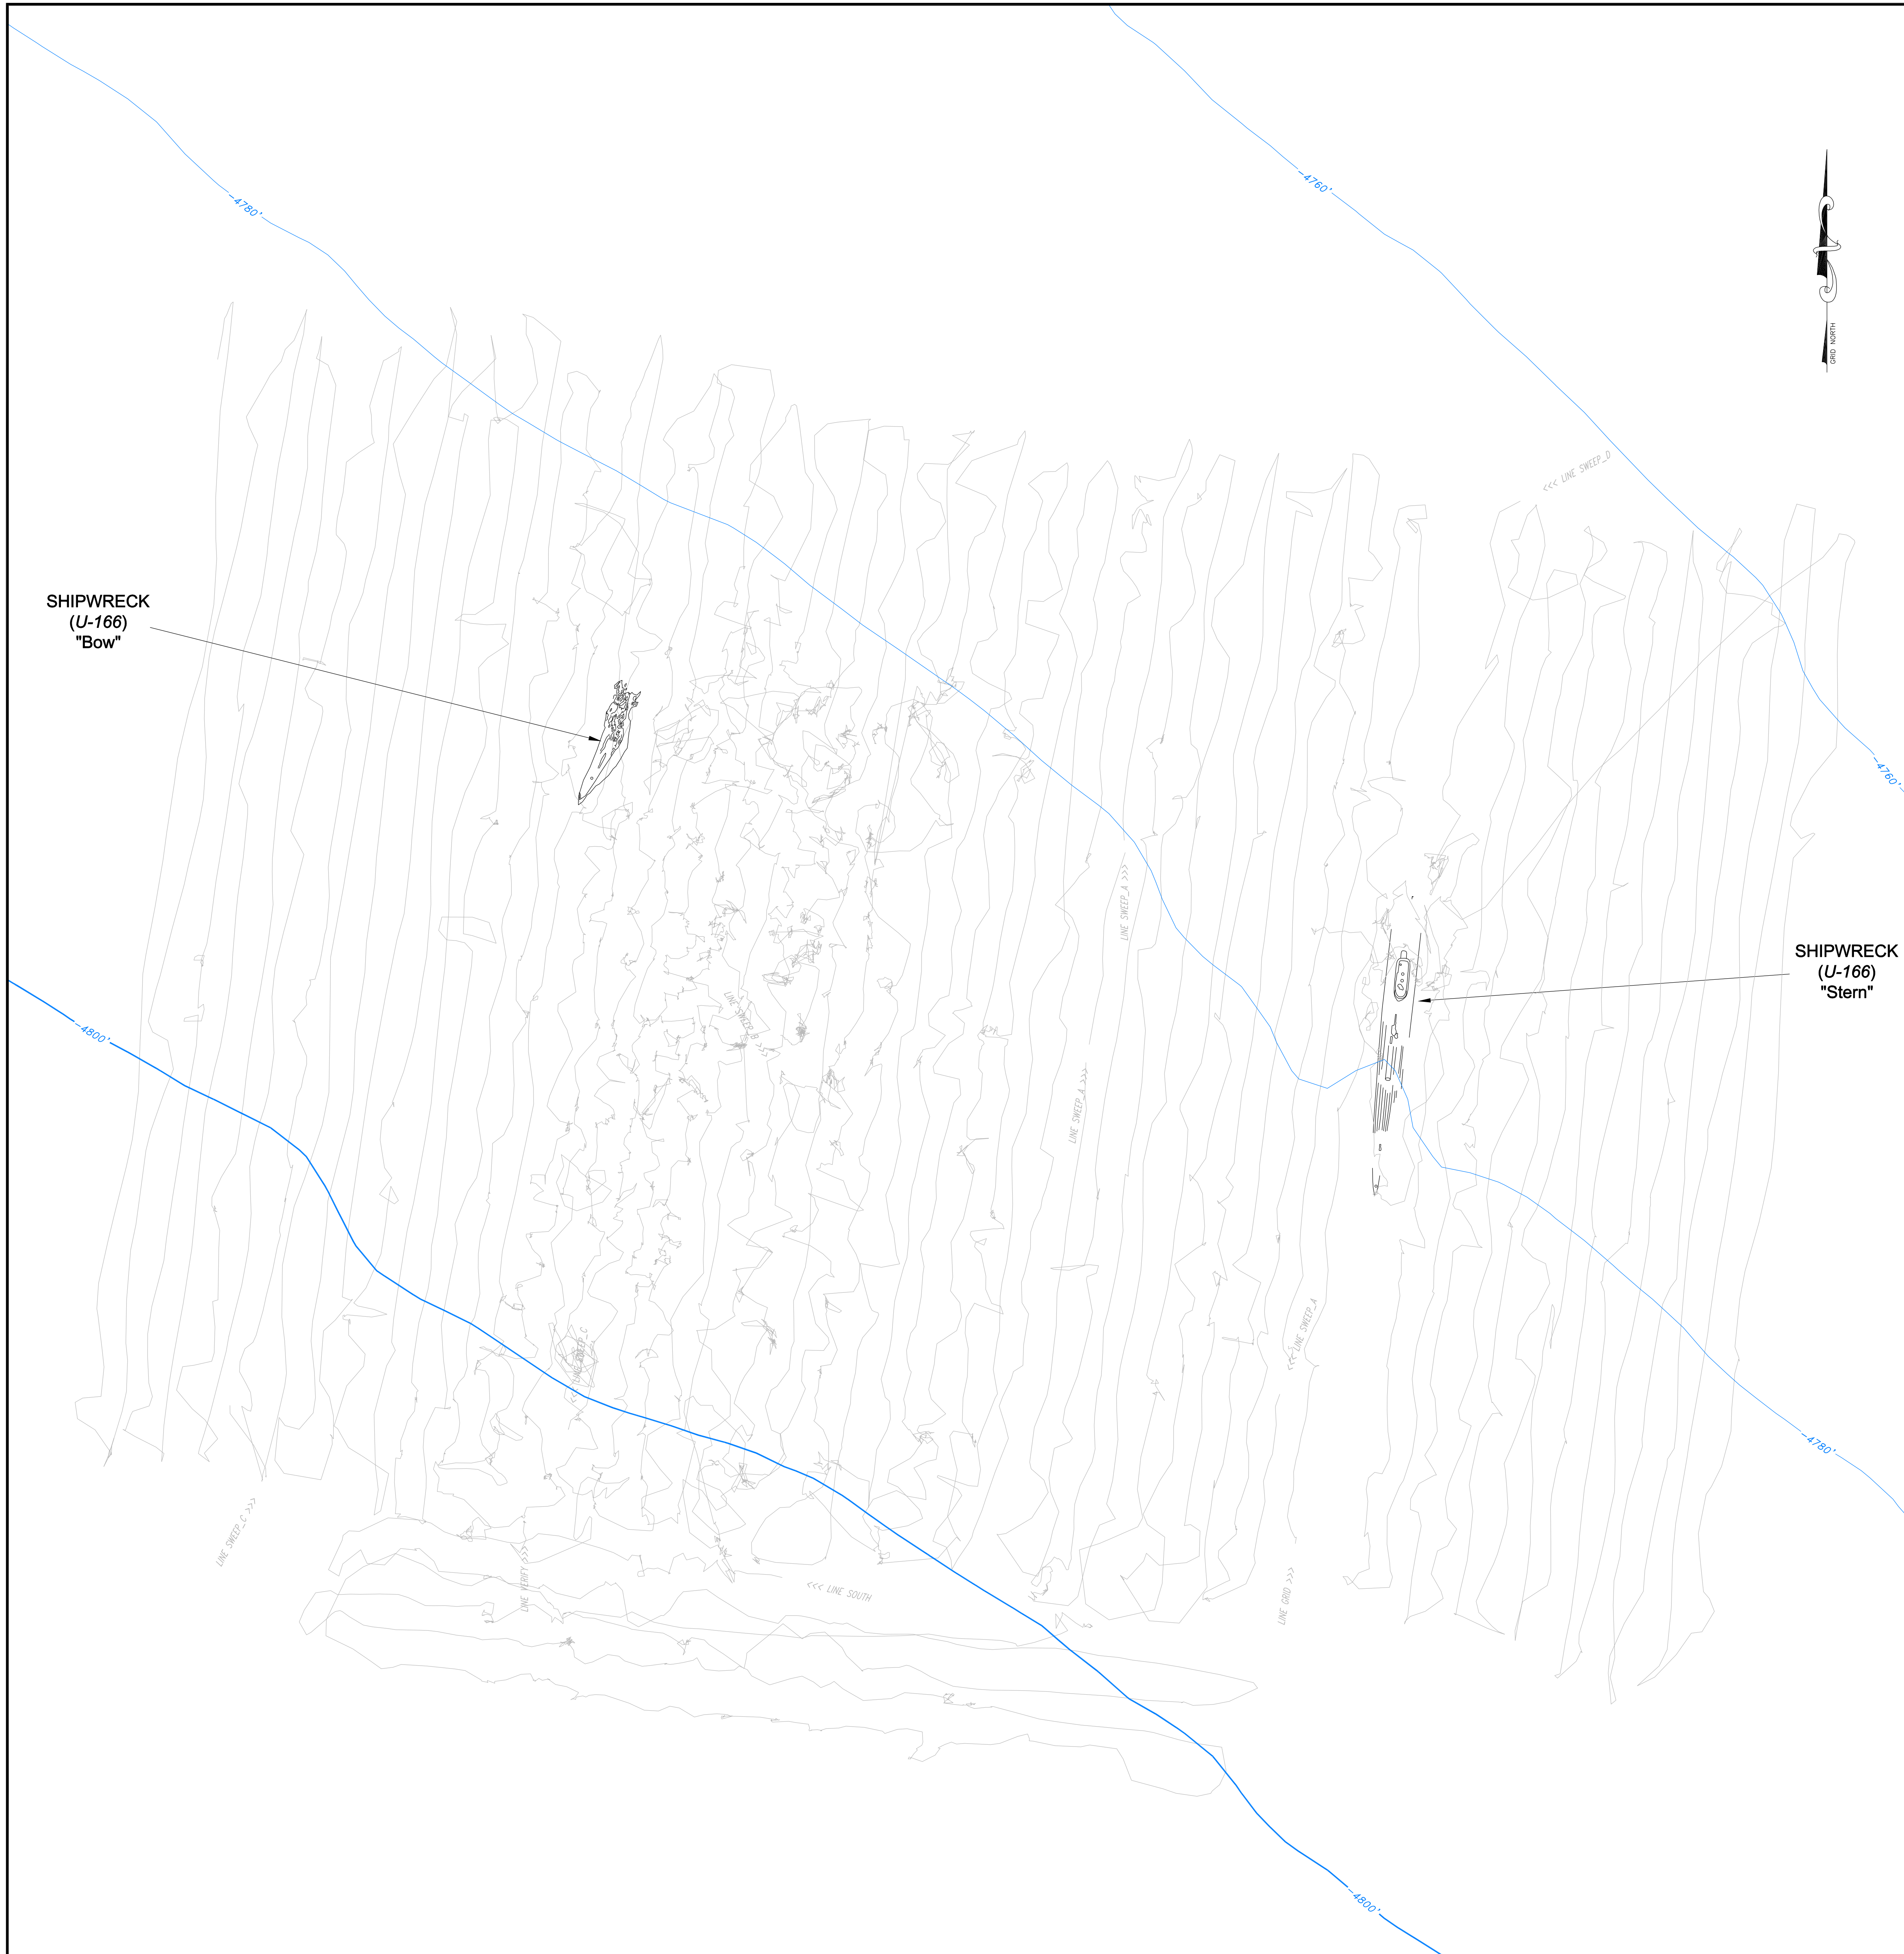
**U-166 INVESTIGATION
 ROV TRACKLINES MAP
 MISSISSIPPI CANYON AREA**

The Innovator ROV would survey the area of the wreck site following a pre-designated survey grid. The survey grid was designed to provide multiple areas of overlapping coverage to insure no areas were missed during the investigation. The grid consisted of sixty-three lines oriented north-to-south and spaced 15-feet apart. During the survey the ROV flew between 6 and 15 feet above the seafloor to minimize the chance of missing wreck remains (Sheet 1).

NOTE: Investigations were carried out on October 5-10, 2003 aboard the NOAA R/V *Ronald H. Brown*. Equipment utilized: Sonsub *Innovator* ROV, C-Nav DGPS, Sonardyne Fusion Long Base Line System, and Sonardyne Pharos Navigation Software. NADCON version 2.1 utilized for WGS84-NAD27 conversions.
